Report Following the Survey of  
Bridge Assets  
for Sample Council  
Inspected Jan-18

Report produced by Moloney Asset Management Systems  
exclusively for Sample Council

Peter Moloney  
Dip CE. CE. EWS. MIEAust  
Moloney Asset Management Systems

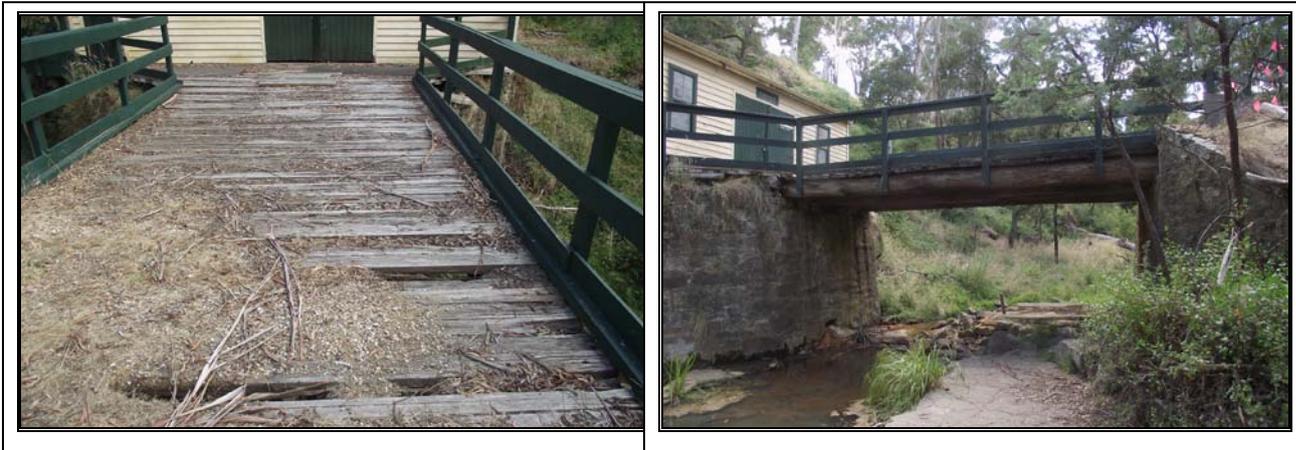
**6.5.1 ID 106- Condition 9.0**

*A small single span timber bridge with stone abutments. The stone abutments are in good condition, the main timber beams probably require replacement and the timber deck has completely failed. It may be able to be redecked and used as a pedestrian bridge but if vehicles are to be taken over it the main beams would also need replacing. It serves only a single shed on the far side and it may not be a council asset.*

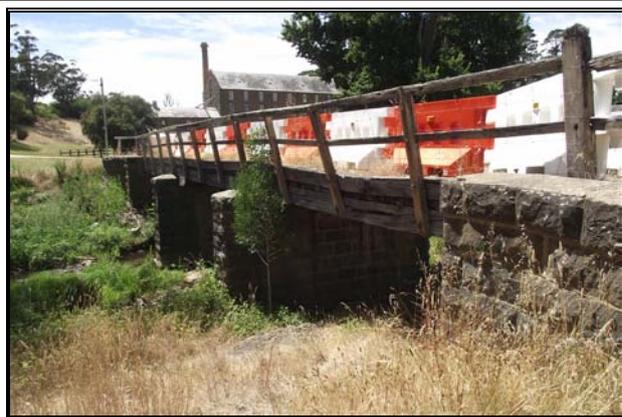
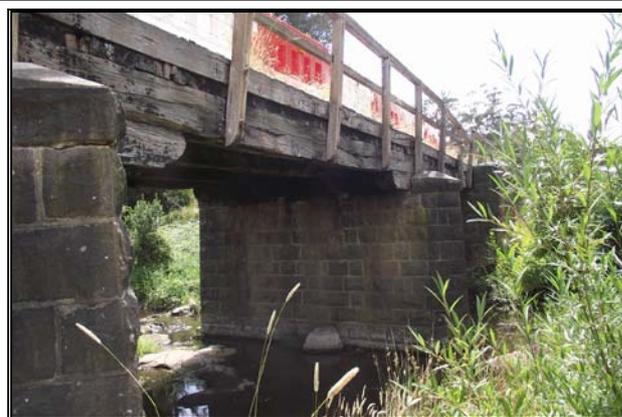
6.5.2 ID 74 – Condition 8.0

*A large triple span timber bridge with very sound stone abutments and piers. The timber main beams and deck have failed. Traffic has been barred from the structure and it is now open to pedestrian traffic only. It would need a complete redeck including the main beams if it is to be reopened to traffic. Foundations abutments and piers are all in excellent condition.*

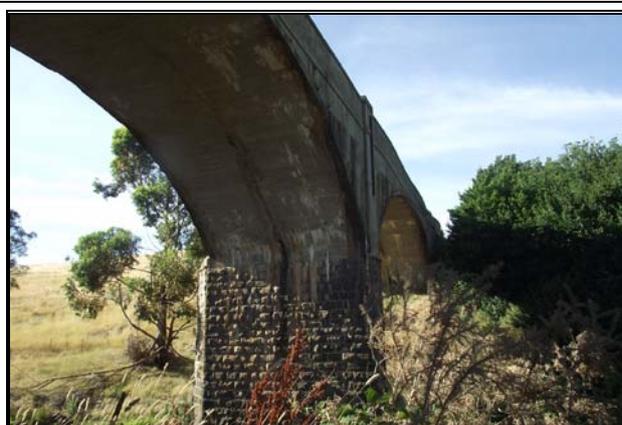
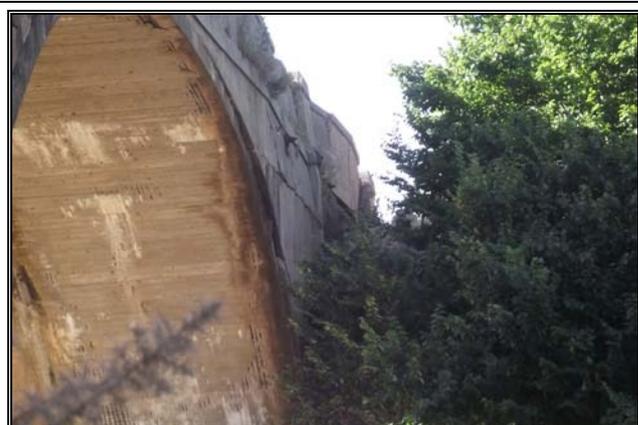
6.5.3 ID 75 – Condition 8.0

*This is a very large twin span stone and concrete arch bridge. The stone foundations, abutments and piers are all in very good condition. There is a little movement in one abutment but not severe. The reinforced concrete arches do have substantial spalling but it is felt that this could be repaired and they may be able to remain in place. The real problem is the un-reinforced mass concrete retaining walls above the RC arches. These have cracked badly and pushed out severely in many places. They probably had steel tie beams between the two sides, but based on the excessive movement it is suspected that these have rusted through.*

*The bridge is of considerable historic importance as Sir John Monash was one of the engineers involved with its design and construction in around 1900. It would also be one of the oldest RC arch bridges in the country. It is felt that the RC arches could be preserved, but all of the mass concrete retaining walls above them would need to be replaced. The concrete retaining walls have deteriorated quite considerably since our last survey in 2013 and are in real danger of collapse at any time. There is a 15 tonne load limit on the structure but it is felt that this should be reduced to 2 - 5 tonne as the deterioration of the concrete retaining walls has been quite measurable and accelerated since 2013.*

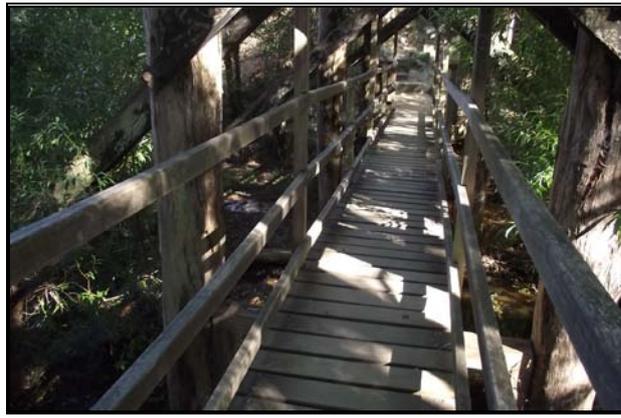
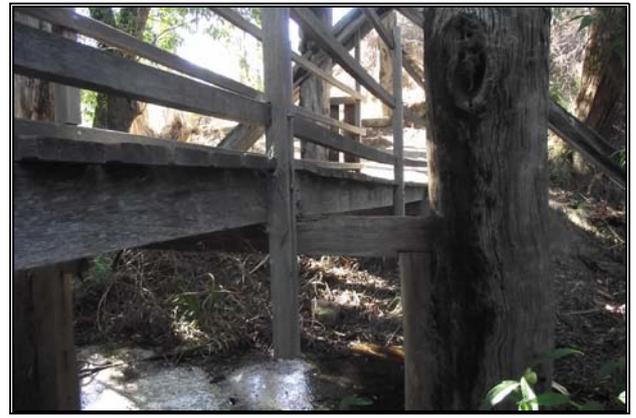
6.5.4 ID 171 – Condition 7.0

*This is a very low construction standard timber footbridge. The timber foundations from the former railway bridge are in poor overall condition and the main timber beams appear to be too small for the span. It is a bridge in generally poor overall condition, but it has not deteriorated much since our last inspection and could remain in service for some time. It is strongly recommended that the gap in the hand rails be reduced if the bridge is to remain in service as the structure is just upstream of a quite high water fall and if a child fell off while water was moving it could be a real problem.*

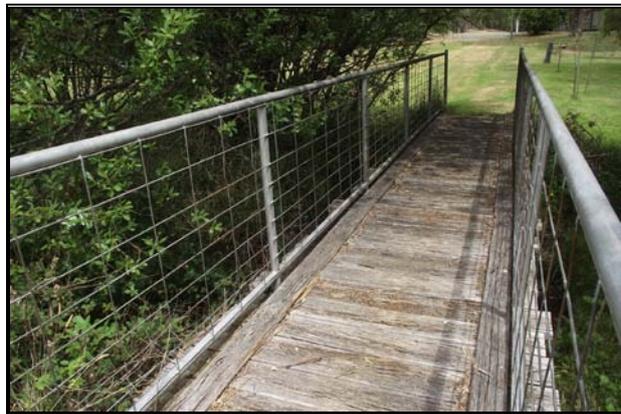
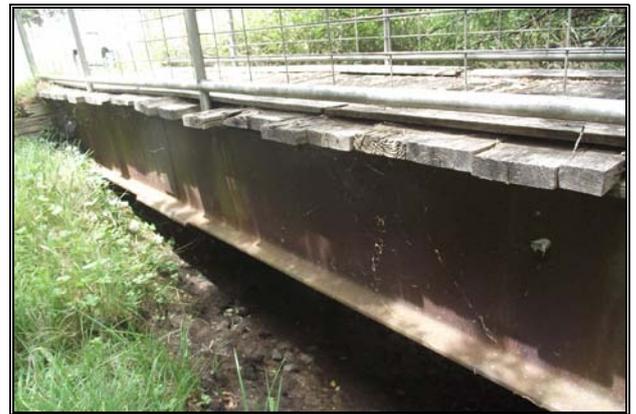
6.5.5 ID 160 – Condition 7.0

*A small single span footbridge that has a very poor condition timber deck and abutments. It does not appear to have a lot of use and if it is to remain in service the timber deck should be replaced ASAP. With a new timber deck it could remain in service for many years.*

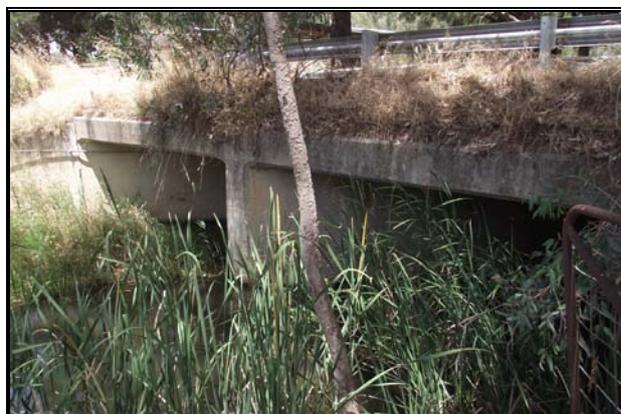
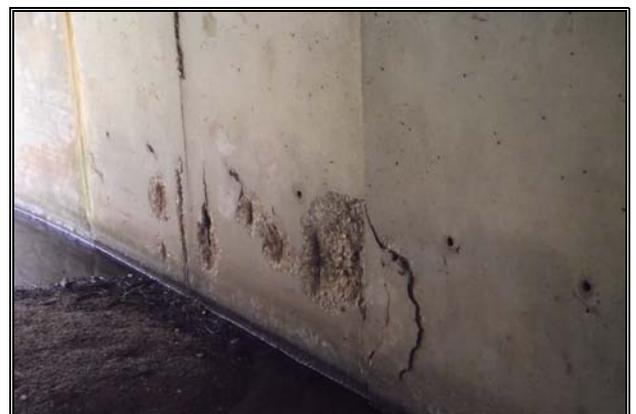
6.5.6 ID 88 – Condition 7.0

*This is a twin cell 3050 x 1800 Precast RC Box Culvert with very bad spalling throughout. It appears that the steel reinforcing was not provided with enough concrete cover and or the concrete was not compacted enough to keep out the water. The spalled areas need to be cleaned off and appropriately covered to prevent further deterioration. With this work undertaken the culvert could remain in service for many more years.*

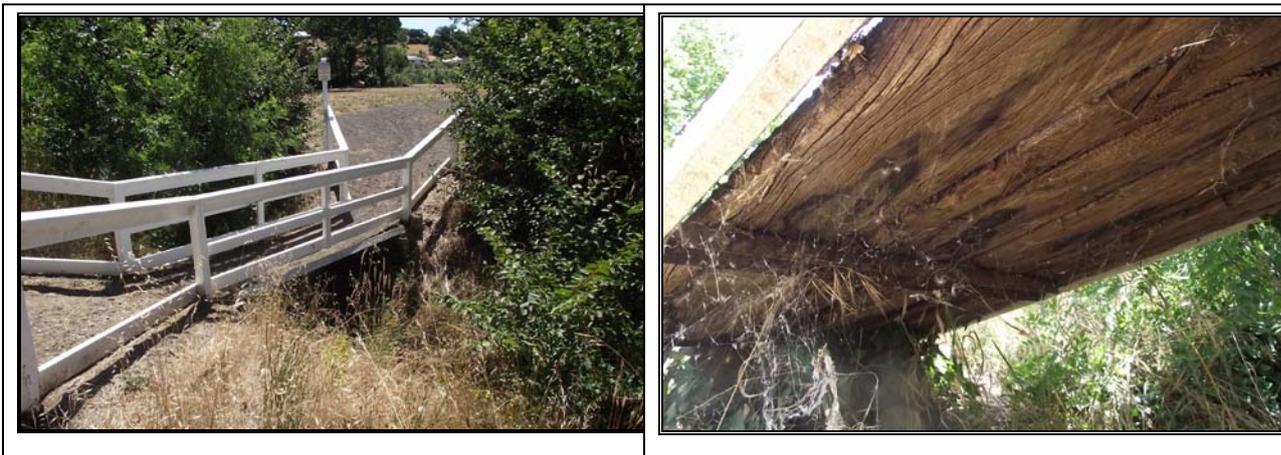
### 6.5.7 ID 156 – Condition 6.5

*A small single span timber footbridge with quite a poor condition timber deck and timber bed log foundations. The 60 x 240 hardwood timber deck planks are spanning 2700 which does appear to be a bit long for the timber size. The structure is not in good condition but it has recently had it's handrails replaced and it could probably remain in service for some years yet.*
